Manhole Inspection Summary

Manhole # S45KK_019MH

Insp Date: **4/15/08 9:36 AM**

Location Address: **Lafayette St**

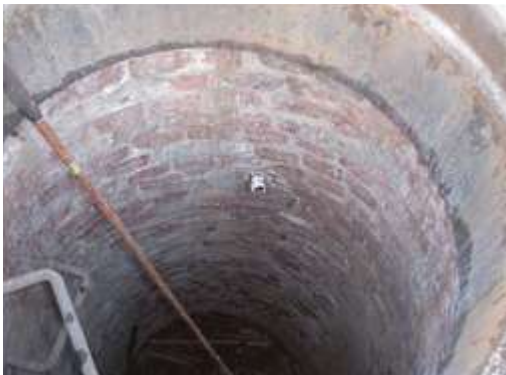
Defect 2

Small pipe protruding from corbel.

Protruding Pipe

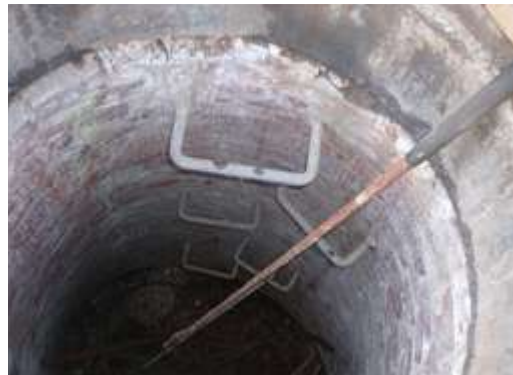
Defect 1

Frame Offset: **2** (in.) Condition: ☐ Sound ☐ Cracked ☒ **Leaks**

Condition: ☐ Sound ☐ Cracked ☐ Root Intrusion ☒ **Loose Brick** ☐ Deteriorated

Infiltration: ☐ None ☐ Joint ☐ Cracks ☒ **Mortar** ☐ Roots ☒ **Wall**

Adjustment Joint

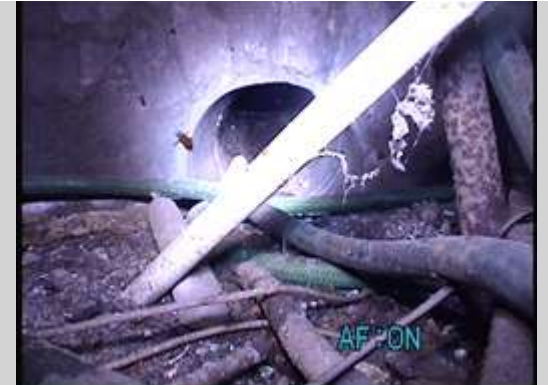
12 O'Clock Outflow

8 in. Circular Gravity Sewer
Pipe Out @ 12 O'Clock

Deposits: ☐ None ☐ Mud ☐ Sludge ☒ **Debris** ☐ Grease

Silt Depth: **2** (in.) Deposits Extent: **Light**
